## 5.8 Geology/Soils

## Dos Colinas EIR Geologic Units

FIGURE  
5.8-1

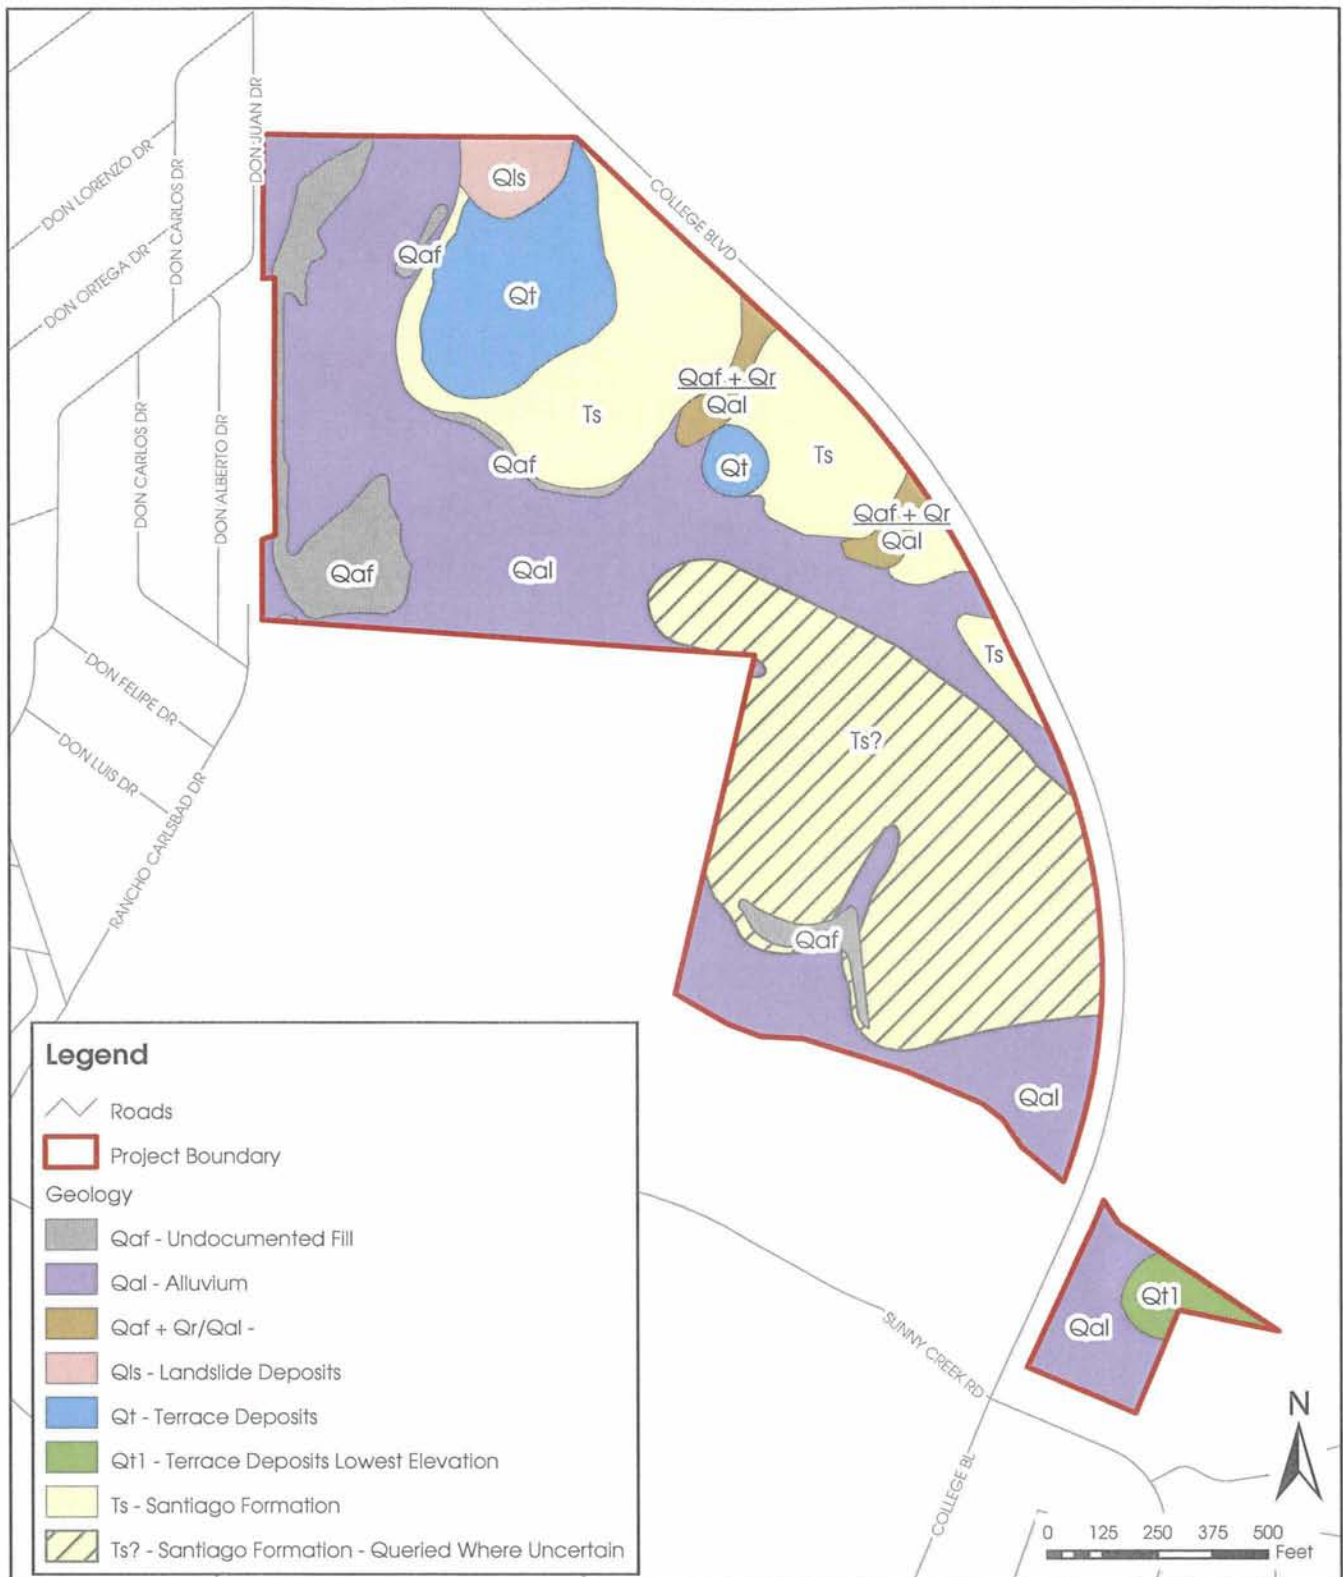
SOURCE: Southern CA Soil & Testing, Inc., 1996; BRG Consulting, Inc., 2010

The sedimentary deposits observed in subsurface explorations in the southeastern portion of the CCRC site appeared uncharacteristic of the Santiago Formation. Many of the observed deposits appear to be only moderately well consolidated, weakly cemented, or uncemented, and highly oxidized. It is probable that some of these deposits are late Tertiary sedimentary deposits or Quaternary terrace deposits rather than Eocene-age Santiago Formation deposits. None of the uncharacteristic Santiago Formation deposits are mapped as terrace deposits, but are instead annotated with a question mark (i.e. the “Santiago Formation?” is mapped on Figure 5.8-1 with the symbol “Ts?”) to indicate the uncertainty.
